PHILIPPINE CENTER for WATER and SANITATION

IRON REMOVAL FILTER

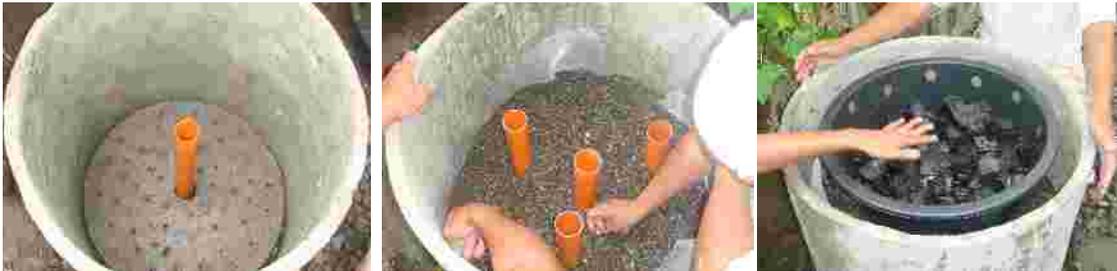
The iron removal filter (IRF) is a cylinder built using ferro-cement construction techniques. Inside, in top to bottom order is a plastic basin full of charcoal, a layer of gravel and an empty space for sedimentation. The water to be treated (in this model the water is assumed to be from a hand pump spout) first passes through the charcoal, aerating it, flows to the empty space at the bottom via a pipe where sedimentation of the precipitated iron takes place, then wells up through the gravel for filtration purposes. The finished water accumulates above the gravel filter, and this elevation enables users to draw it.

Engineers of the Philippine Center for Water and Sanitation (PCWS) teach communities how to construct iron removal filters.

To use it for the first time, the filter is filled with water and allowed to overflow a little. The first discharge is turbid from the gravel, but this clears up after a day or so of use. After placing their buckets under the tap, the users just pump the hand pump, and by gravity the water enters and flows through the filter, displacing the previous treated contents, which then overflows thru the taps into their buckets.

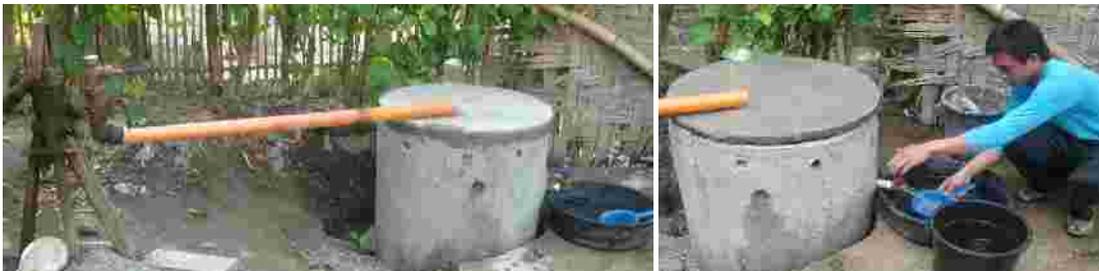
It is possible that the charcoal may eventually clog up. The basin can then be removed from the IRF and cleaned by running water through it, assisting the process by manual agitation of the charcoal chunks.

The gravel may also eventually clog up occasionally. Cleaning it is also by manual agitation while recycling water through the IRF. A bucket is placed under the open tap and the contents rilled by pouring dipper by dipper back through the charcoal basin. In c where deposits have built up in the sedimentation space, a drain can be opened to clean this out. The worst that can happen is that the unit may eventually need overhauling. All parts are then taken out and cleaned, and clogs and leaks repaired.
